Manhole Inspection Summary

Manhole # S21GG_053MH

Insp Date: **6/15/07 12:45 PM**

Location Address: **1700 BRUCE CT**

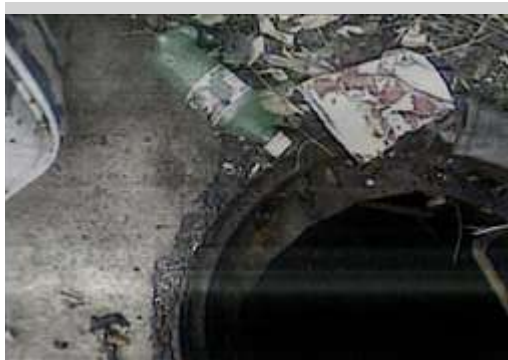
Defect 1

Frame Offset: **3** (in.) Condition: ☒ Sound ☐ Cracked ☐ Leaks

FRAME OFFSET

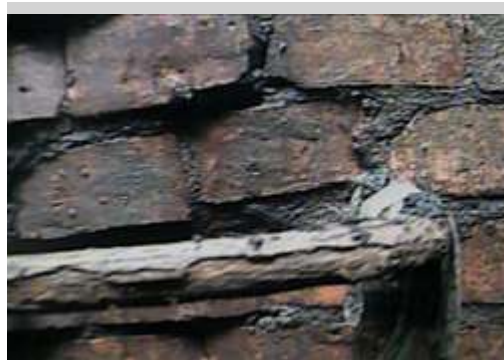
Defect 3

Steps Count: **3** Missing: **0** ☒ **Corroded**

Surcharge ☒ **Evidence Of Surcharge** Depth: **1.5** (ft.) ☐ Active Surcharge Present

CORRODED STEPS AND EVIDENCE
OF SURCHARGE

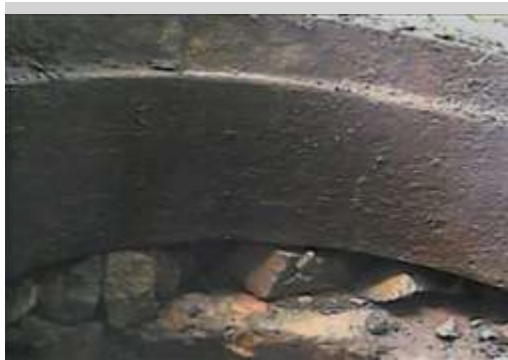
Defect 2

Chimney / Frame Adjustment ☒ Exists Material: **Brick** ☐ Parged Height: **3** (in.)

Condition: ☐ Sound ☐ Cracked ☐ Root Intrusion ☐ Loose Brick ☒ **Deteriorated**

DETERIORATION OF CHIMNEY

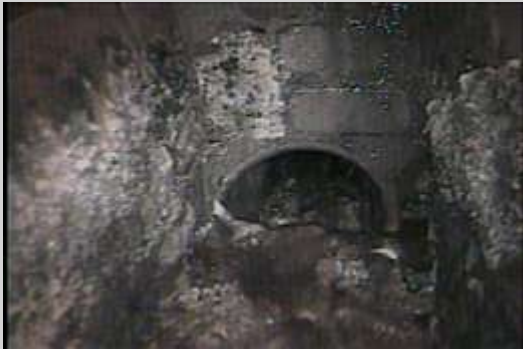
12 O'Clock Outflow

DEBRIS IN CHANNEL

Pipe Height: **8.4** (in.) Rod and Bar (Angled)
Pipe Material: **Clay** ☐ Pipe Lined
Invert Depth: **8.40** (ft.) Flow Characteristics: **Slow**
Deposits: ☐ None ☐ Mud ☐ Sludge ☒ **Debris** ☐ Grease
Silt Depth: **5** (in.) Deposits Extent: **Heavy**
Infiltration: **None** Pipe Seal Cond: **Sound**

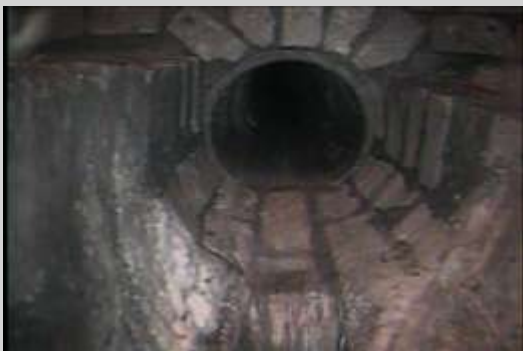
6 O'Clock Inflow

Pipe Height: **8.4** (in.) Rod and Bar (Angled)
Pipe Material: **Clay** ☐ Pipe Lined
Invert Depth: **7.98** (ft.) Flow Characteristics: **Slow**
Deposits: ☒ **None** ☐ Mud ☐ Sludge ☐ Debris ☐ Grease
Silt Depth: (in.) Deposits Extent:
Infiltration: **None** Pipe Seal Cond: **Sound**
